TOYOTA

BE-0003T-0116

# Technical Service Bulletin

**Toyota Touch2 : Software update including major bug fixes and patch for "00000000" software version**

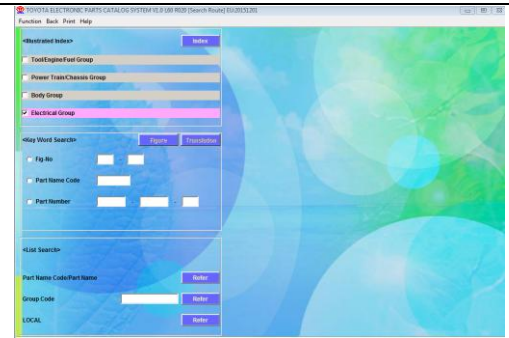
III	<p>5. Uncheck "Tool/Engine/Fuel Group", "Power Train/Chassis Group" and "Body Group"</p> <p>6. <b>Make sure that only "Electrical Group" remains checked!</b></p> <p>7. Press Index-button</p>

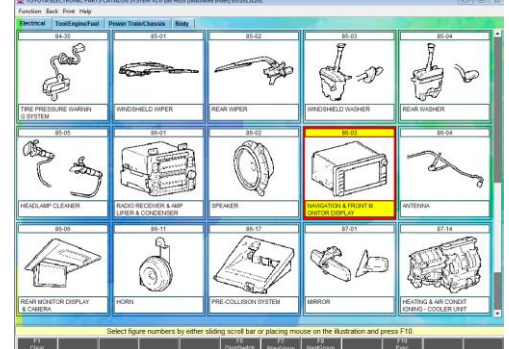
IV	<p>8. Select "NAVIGATION &amp; FRONT MONITOR DISPLAY" icon</p> <p>9. Press "F10 Exec"</p>

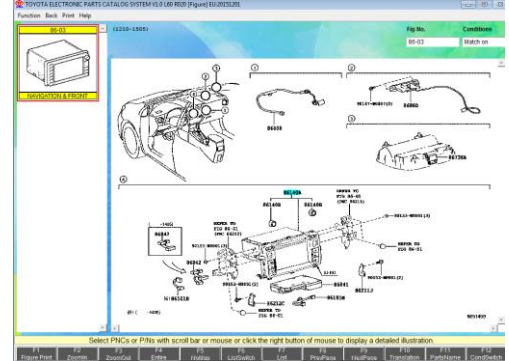
V	<p>10. Select "86140A" indicated part (RECEIVER ASSY, RADIO &amp; DISPLAY)</p> <p>11. Press "F10 Translation"</p>

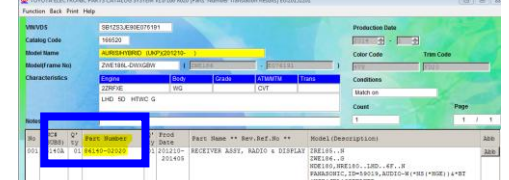
VI	<p>12. Installed DA-unit part number will become visible</p> <p>13. Confirm if part number is listed in (*2) reference table -&gt; see Parts Information section.</p>

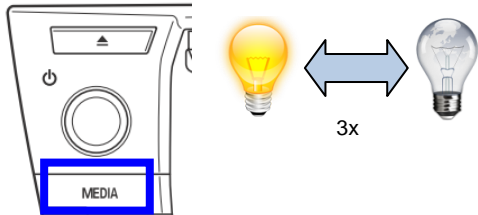
I	<p><b>Check Display Audio unit software version</b></p> <p>Press and hold "MEDIA" button and turn ON/OFF illumination 3 times to enter the "Service Menu".</p>

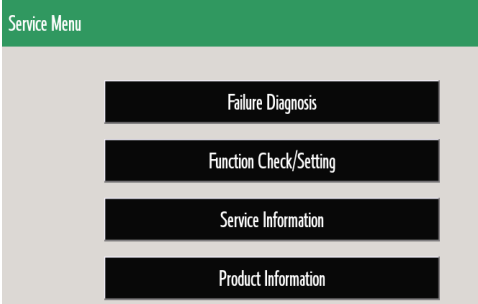
II	<p>Push "Service Information"</p>

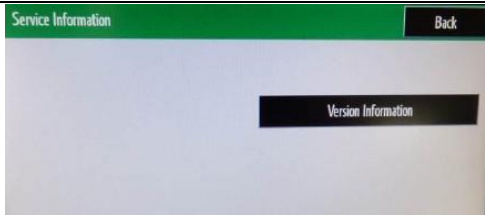
III	Push "Version Information"

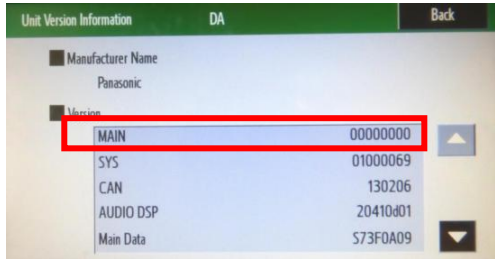
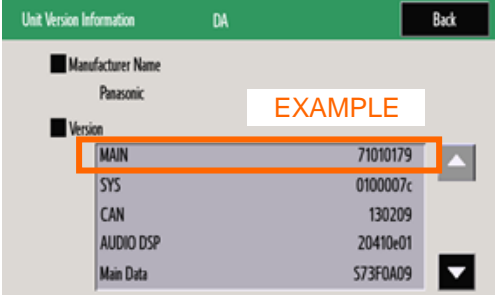
V	<p>Check "Version" under "MAIN".</p> <p><u>For version "00000000" check:</u> If the indicated software version shows 00000000, the unit requires the software patch.</p> <p><u>For DA-software version check:</u> Is the indicated software version LOWER than the software version listed in the (*2) reference table, the unit requires the designated RC-software update.</p>

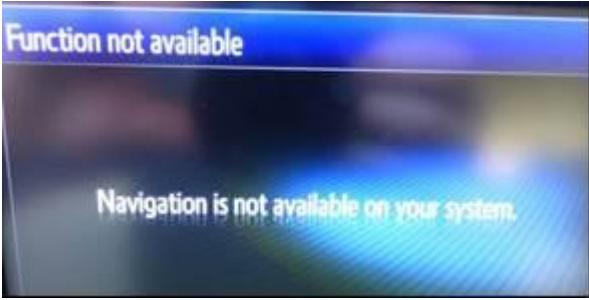
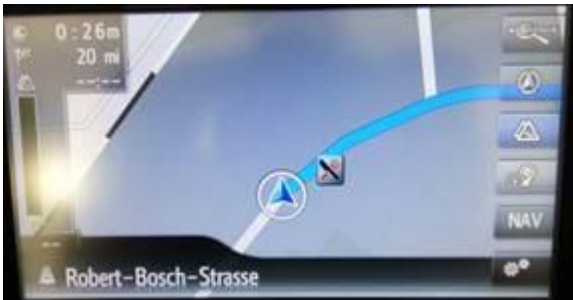
2	<p>Display Audio function only (no NAVI extension box present) : Perform the Display Audio software patch via USB-stick. [2]</p> <p>Display Audio with NAVI extension box : Perform Display Audio software patch via CD-R disc. [1]</p>

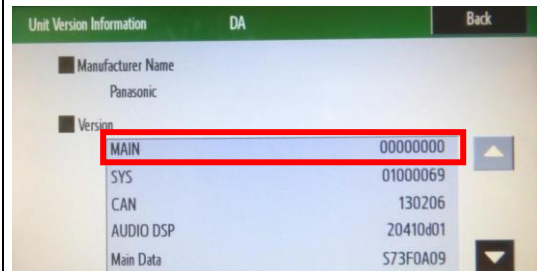
<p>Check "Version" under "MAIN".</p> <p>Refer to 1] version "00000000" check: If the indicated software version shows 00000000 the unit requires the software patch to be performed.</p>

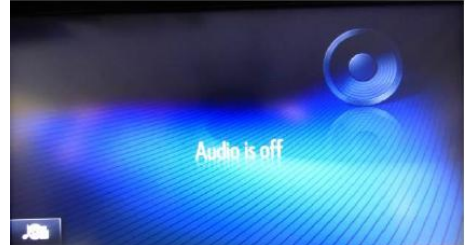
<p>Engine must be running when performing update or recovery by CD-R disc.</p>	
II	Switch Audio OFF

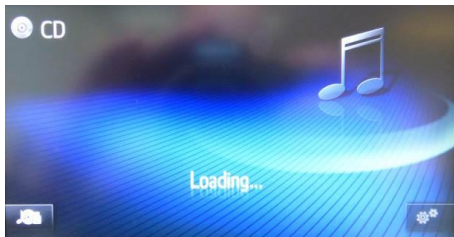
III	<p>Insert prepared software recovery patch CD-R disc</p> <p><u>Remark:</u> The "Loading..." progress might take up to over 1 minute to complete.</p>

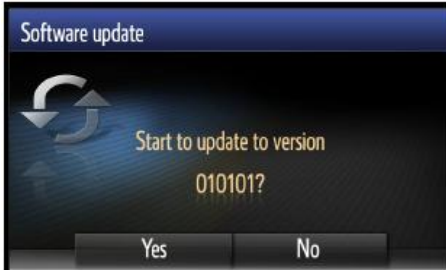
IV	<p>Start the update (recovery) by selecting "Yes"</p>

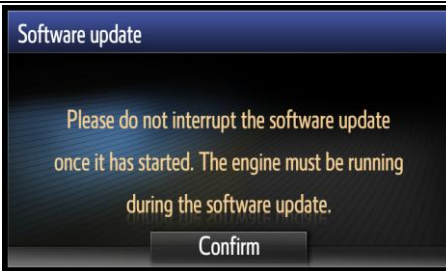
V	<p>Push "Confirm" to start the update process</p>

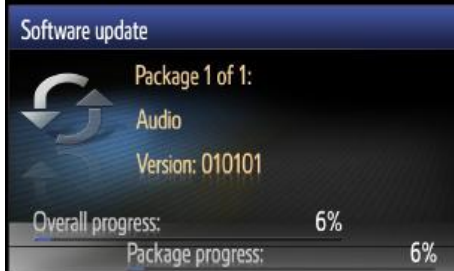
VI	<p>The update will start and a progress bar will be displayed</p> <p><u>Remark:</u> First visible change to the progress bar might only be seen after about 2 minutes.</p>

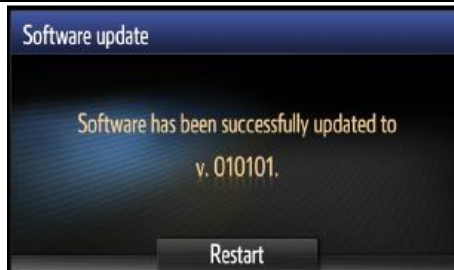
VII	<p>After the software update has fully completed, following screen appears.</p> <p>Remove CD-R disc (will be ejected automatically)</p> <p>Press "Restart" → Display Audio-unit will reset itself.</p>

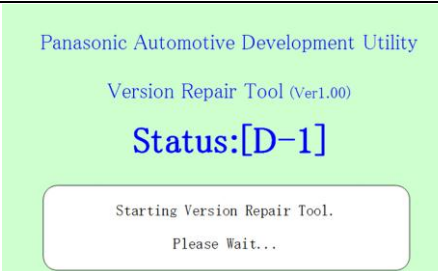
VIII	<p>After unit restart (reset) and the appearance of the Toyota logo,</p> <p>Screen Status:[D-1] will be displayed.</p> <p>Please wait approximately 30 seconds.</p>

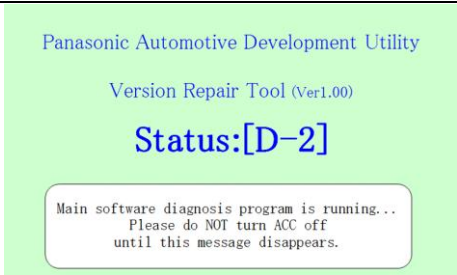
IX	<p>Diagnosis of the recovered software is starting.</p> <p>Screen Status:[D-2] will be displayed until completion.</p> <p>The diagnosis takes approximately up to 15 minutes.</p> <p>

Do not turn OFF ACC during diagnosis step.</p>

If the designated RC-software update will not be performed immediately, at every ACC OFF/ON cycle, the Display Audio-unit will always first cycle through screens Status:[D-1], Status:[D-2] and Status:[F-1] before it will show the "Audio is OFF" screen.

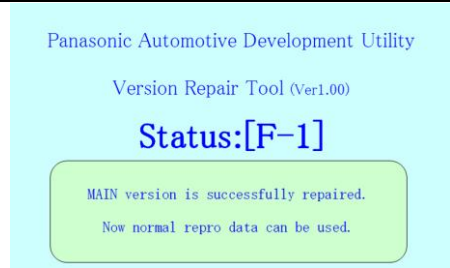
X	<p>When diagnosis is completed, screen Status:[F-1] will be displayed for approximately 10 seconds.</p> <p>Afterwards the AUDIO OFF screen will be displayed again.</p>

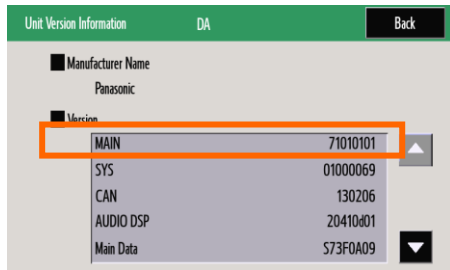
XI	<p><b><u>Result Check</u></b></p> <p>Enter the Service Menu and check the new Software Version of the Radio.</p> <p>For exact operation, please refer again to "1] Check the version of the software installed on the Display Audio-unit"</p> <p>Check "Version" under "MAIN." → The recovered Version should show the software version as per below included Recovered Software Version matrix (*3)</p>

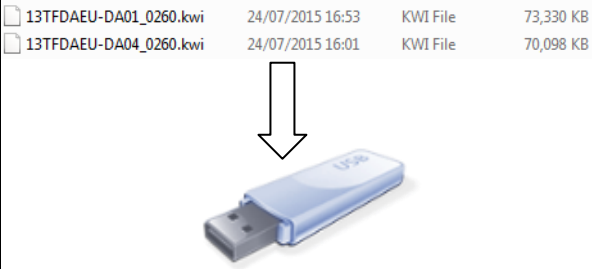
No.	Action	Detail
I	<p>Use an empty USB-stick</p> <p>Copy all the .kwi-files present under the "00000000 RECOVERY USB"-directory in the root folder of the blank USB-stick.</p> <p>Note: The recovery patch software is common and is valid for all related and intended vehicle DA-units.</p> <p>Important: Do not copy any other files onto the USB-stick.</p>

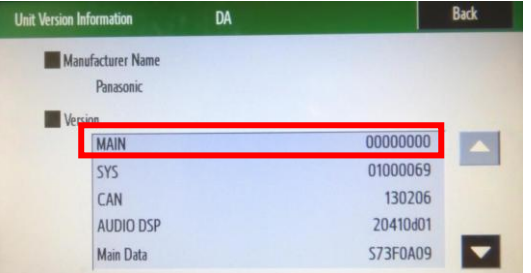
<p>Check "Version" under "MAIN".</p> <p>Refer to section 1] version "00000000" check: If the indicated software version shows 00000000 the unit requires the software patch to be performed.</p>

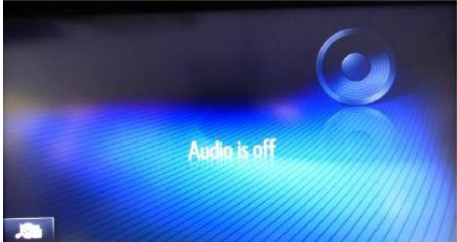
No.	Action	Detail
I	Put ACC ON	
II	Switch Audio OFF

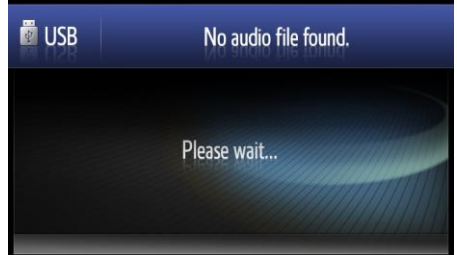
III	Insert prepared software recovery patch USB-stick

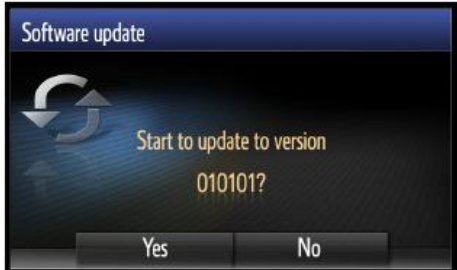
IV	Start the update (recovery) by selecting "Yes"

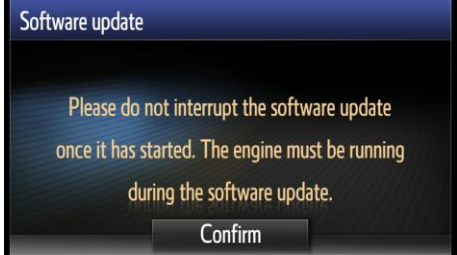
V	Push "Confirm" to start the update process

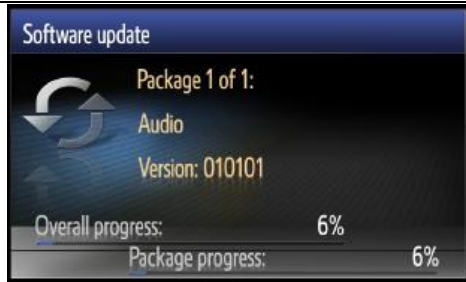
VI	<p>The update will start and a progress bar will be displayed</p> <p><u>Remark:</u> The progress bar will take about 3 minutes to complete fully (100%).</p>

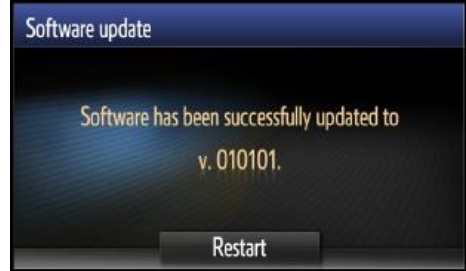
VII	<p>After the software update has fully completed, following screen appears.</p> <p>Remove the USB-stick</p> <p>Press "Restart" → Display Audio-unit will reset itself.</p>

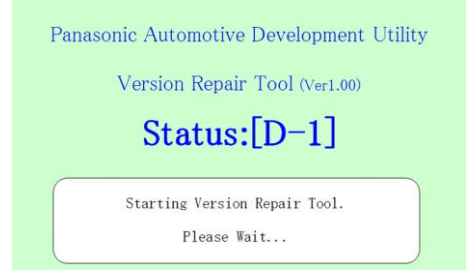
VIII	<p>After unit restart (reset) and the appearance of the Toyota logo, screen Status:[D-1] will be displayed.</p> <p>Please wait approximately 30 seconds.</p>

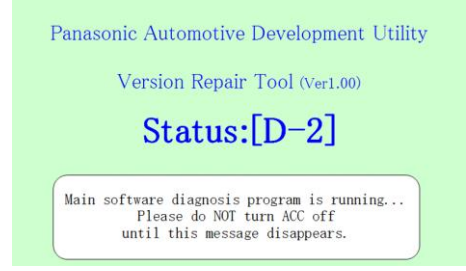
IX	<p>Diagnosis of the recovered software is starting.</p> <p>Screen Status:[D-2] will be displayed until completion.</p> <p>The diagnosis will only take a few seconds.</p> <p>

Do not turn OFF ACC during diagnosis step.</p>

If RC-software update will not be performed immediately, at every ACC OFF/ON cycle, the Display Audio-unit will always first cycle through screens Status:[D-1], Status:[D-2] and Status:[F-1] before it will show the "Audio is OFF" screen.

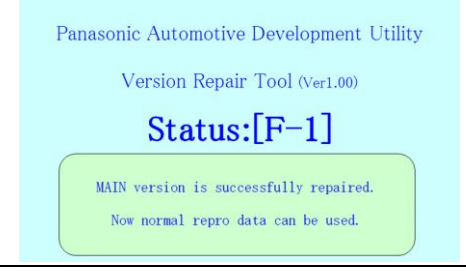
X	<p>When diagnosis is completed, screen Status:[F-1] will be displayed for approximately 10 seconds.</p> <p>Afterwards the AUDIO OFF screen will be displayed again.</p>

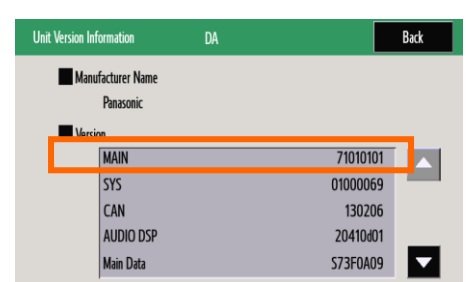
XI	<p><b><u>Result Check</u></b></p> <p>Enter the Service Menu and check the new Software Version of the Radio.</p> <p>For exact operation, please refer to section "1] Check the version of the software installed on the Display Audio-unit"</p> <p>Check "Version" under "MAIN." → The recovered Version should show the software version as per included Recovered Software Version matrix (*3).</p>

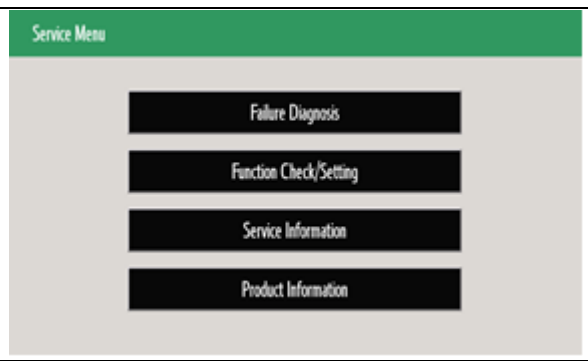
2	Push on "Service Information"

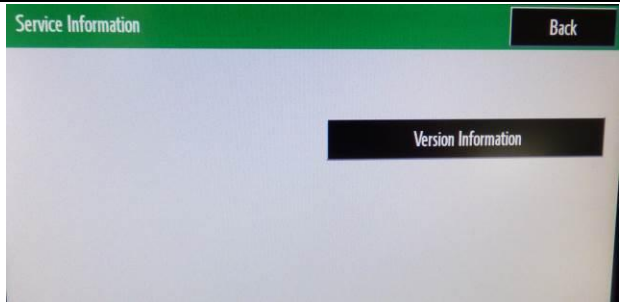
3	Push on "Version information"

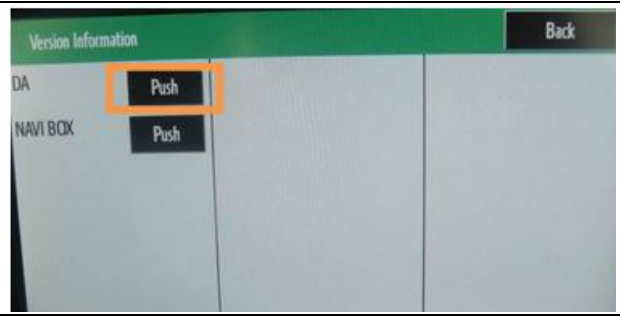
4	Next to DA select "Push"

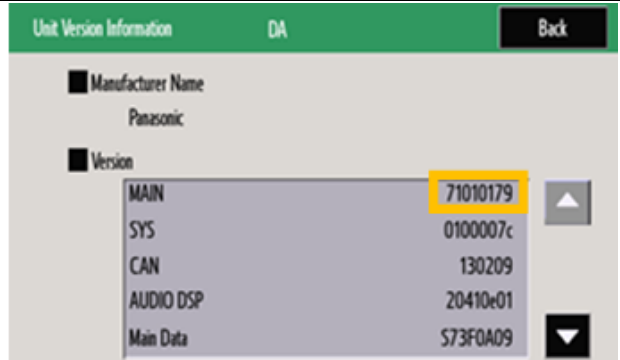
5	Check "Version" under "MAIN." Is the version LOWER than the Version Shown in (*2) ref. table? The Radio needs a software update.

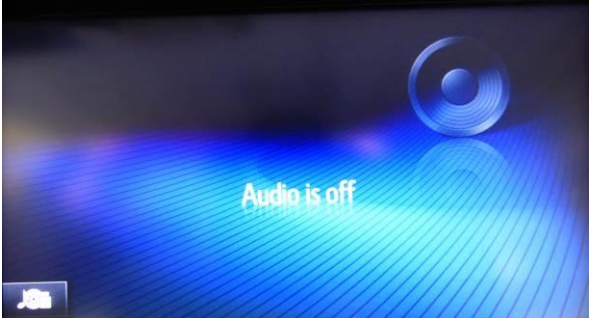
<p>Engine must be running when performing update by CD</p>	
5	<p>Switch Audio off</p> <p>Insert the correct update medium</p> <ul style="list-style-type: none"> <li>- USB</li> <li>- CD-R</li> </ul>

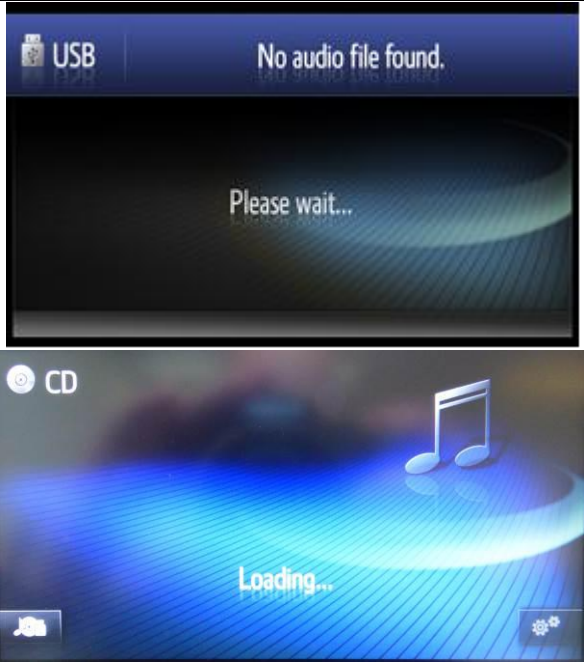
6	<p>Update screen when using USB</p> <p>Update screen when using CD-R</p>

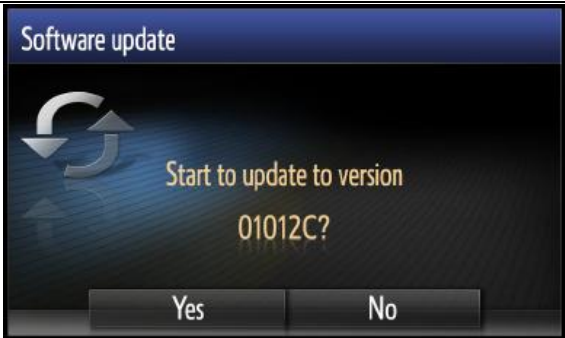
7	Start the update by selecting "Yes"

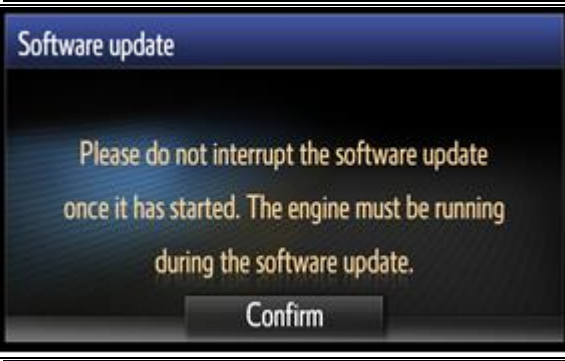
8	Push "Confirm" to start the update

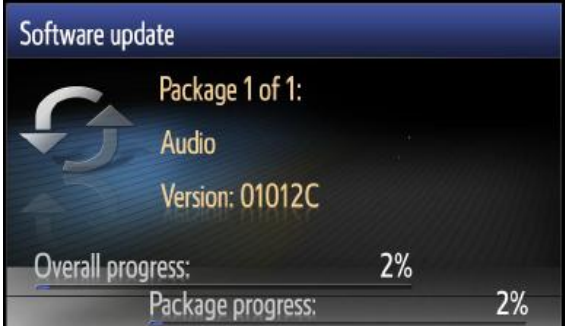
9	The update will start and a progress bar will be displayed.

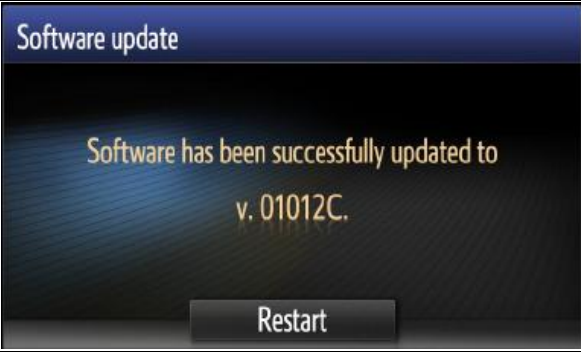
10	<p>After the software update is finished the following screen appears</p> <p>Remove the USB or CD-R</p> <p>Push "Restart"</p>

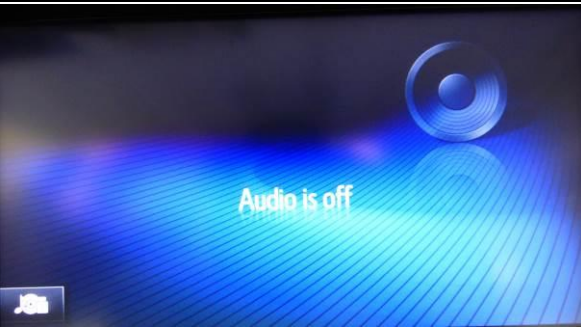
11	<p>After restart the following screen appears</p>
